Monitoring technical state of pipelines in difficult conditions

Citation: *Dmitrievsky A.N., Eremin N.A., Husnutdinov L.A.* Monitoring technical state of pipelines in difficult conditions // Actual Problems of Oil and Gas. 2019. Iss. 3(26). <https://doi.org/10.29222/ipng.2078-5712.2019-26.art12>

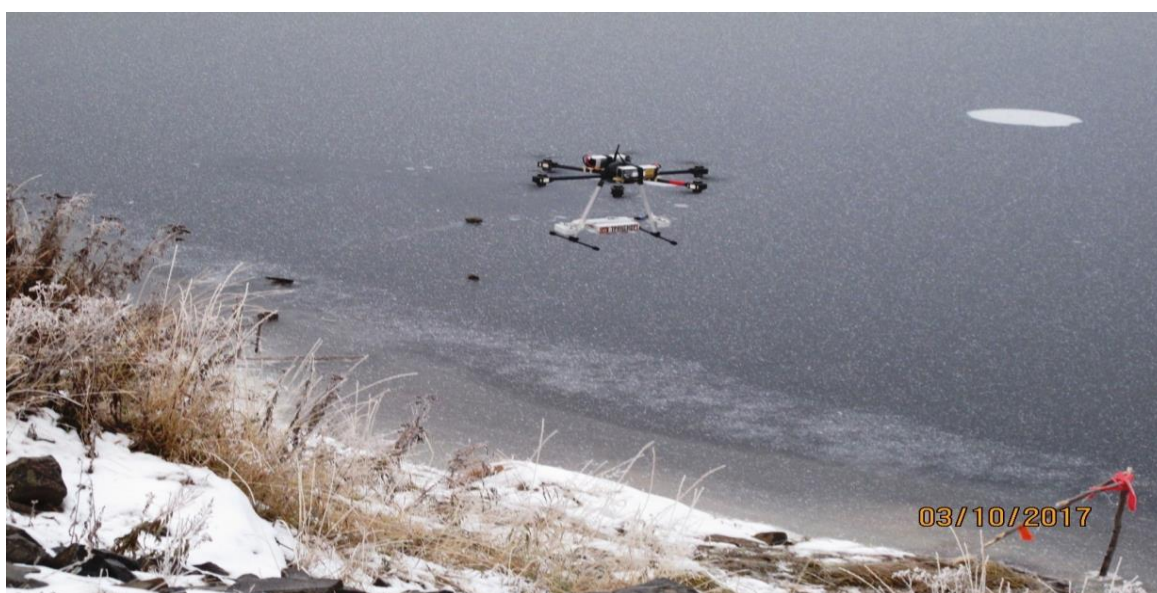
Figure. The innovative technology of contactless diagnostics of pipelines based on multicopter

In October 2017, the world's first project to diagnose the gas pipeline of OJSC Alrosa Gas at water crossings across the Vilyui and the Bolshaya Butobiya rivers, with a total length of about 2 km using a multicopter, was successfully completed. The innovative technology of contactless diagnostics of pipelines based on multicopter was created by the scientific centers of the Oil and Gas Research Institute of the Russian Academy of Sciences: magnetic tomography, the supervisor of the Ph.D. S.S. Kamaeva, and monitoring and geophysical studies using the UAV, the supervisor, Ph.D. A.D. Chernikov (see Figure). As a result of the experimental work on the inspection of water crossings of the gas pipeline of the company – OJSC Alrosa Gas – by the method of magnetic tomography using unmanned aerial vehicles, the main elements of the robotic technology of inspection of the state of the pipelines were worked out [10, 11].
